Title: Monitoring of remediation works to arrest stream degradation in an agriculture-dominated catchment

Monitoring of remediation works to arrest stream degradation in an agriculture-dominated catchment

Andrea L. Wilson, Robyn J. Watts, Ken J. Page and Remy Dehaan

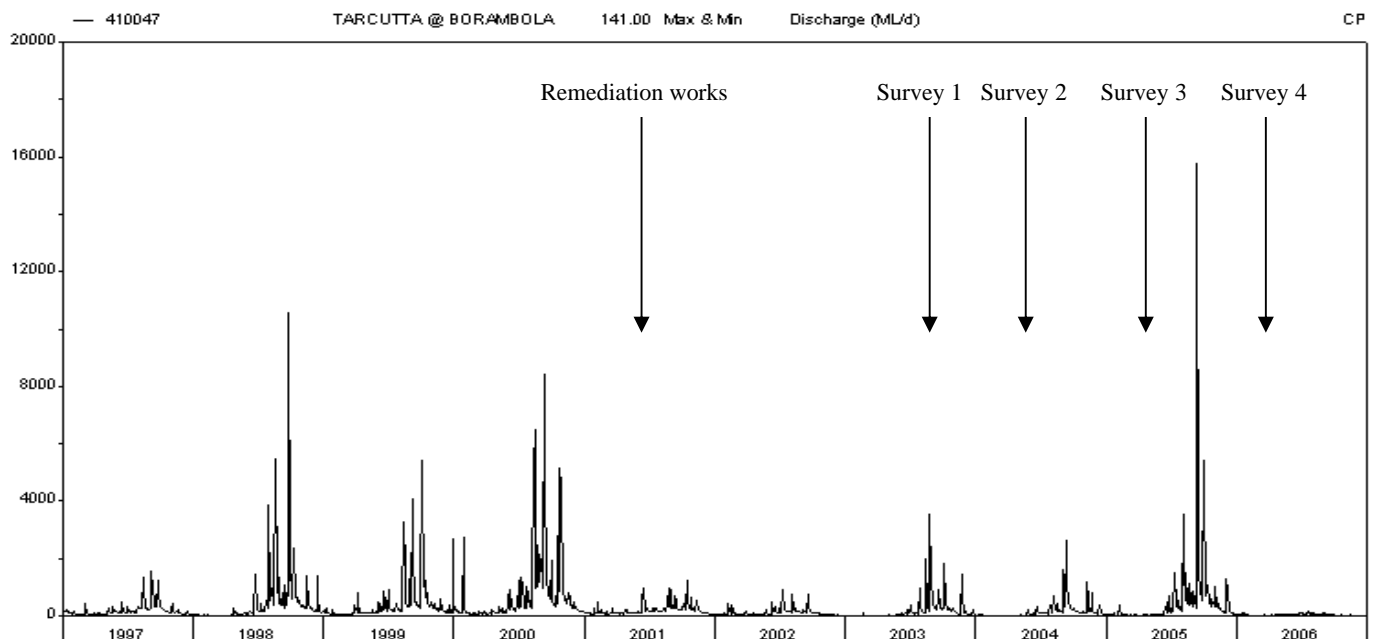
Since the implementation of the remediation works in 2001, the catchment has been subject to prolonged drought conditions (Figure 2). Although continuous monitoring of creek discharge was not undertaken at the remediated reach, a nearby permanent gauging station was used to examine the peaks of flow experienced in the catchment. Flow data obtained from the Borambola gauge (Figure 1 & 2) indicated that two elevated flow events were experienced at the study site in 2003 and 2004, but these were probably relatively small. Potentially erosive high flows were not received at the study site until late in 2005.

Figure 2. Hydrograph of stream discharge between 1997 and 2006 downstream of study site on Tarcutta Creek (<http://waterinfo.nsw.gov.au/cgi-bin/browse.epl?site=410047>).

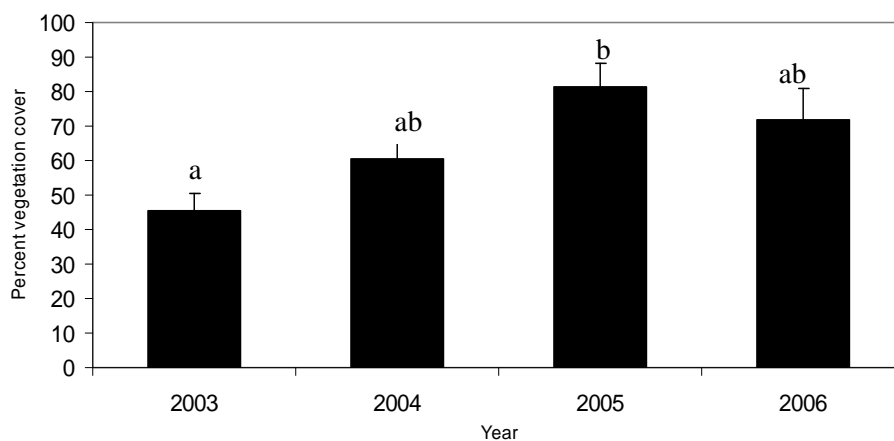
Comparison of percent vegetation cover data showed a significant increase between 2003 and 2005 (ANOVA; $P < 0.05$; Figure 3). This increase occurred despite the drought conditions existing across the catchment and the reintroduction of cattle into the remediated area for intermittent grazing on a number of occasions. The use of infrequent livestock grazing was necessary as feed for cattle became increasingly scarce during the drought. There also appeared to be a decrease in vegetation cover after the high erosive flows that occurred in late 2005, although this was not statistically significant. Inspection of the study sites after these increased flows showed evidence of in-stream vegetation being scoured and tree damage.

Figure 3. Average percent cover of vegetation along transects ($n=3$) surveyed within Umbango Creek in 2003, 2004, 2005 and 2006. Different letters indicate statistically significant differences (ANOVA; $P < 0.05$).

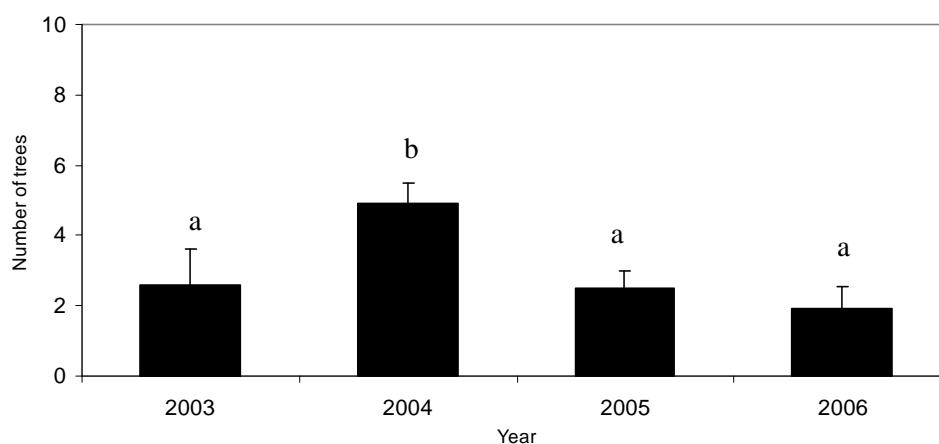
The average number of trees and shrubs counted along the study transects within the remediated reaches significantly increased between 2003 and 2004 (ANOVA; $P < 0.05$; Figure 4). This increase was largely the result of natural regeneration. However, tree abundance was subsequently reduced by grazing and flood damage. The assessments of grazing damage inflicted on trees demonstrated substantial impacts in 2003 and 2004, where 77% and 64% of trees respectively were recorded as having severe damage. Only 7% of trees were recorded as having severe grazing damage in 2005. These data indicate that some recovery from grazing was evident at the study site. Importantly, the abundance of trees in 2005 and 2006 was not significantly lower than 2003 levels (ANOVA; $P > 0.05$).

Figure 4. Number of trees (standardised/10m) ($n=3$) at Umbango Creek in 2003, 2004, 2005 and 2006. Different letters indicate statistically significant differences (ANOVA; $P < 0.05$).

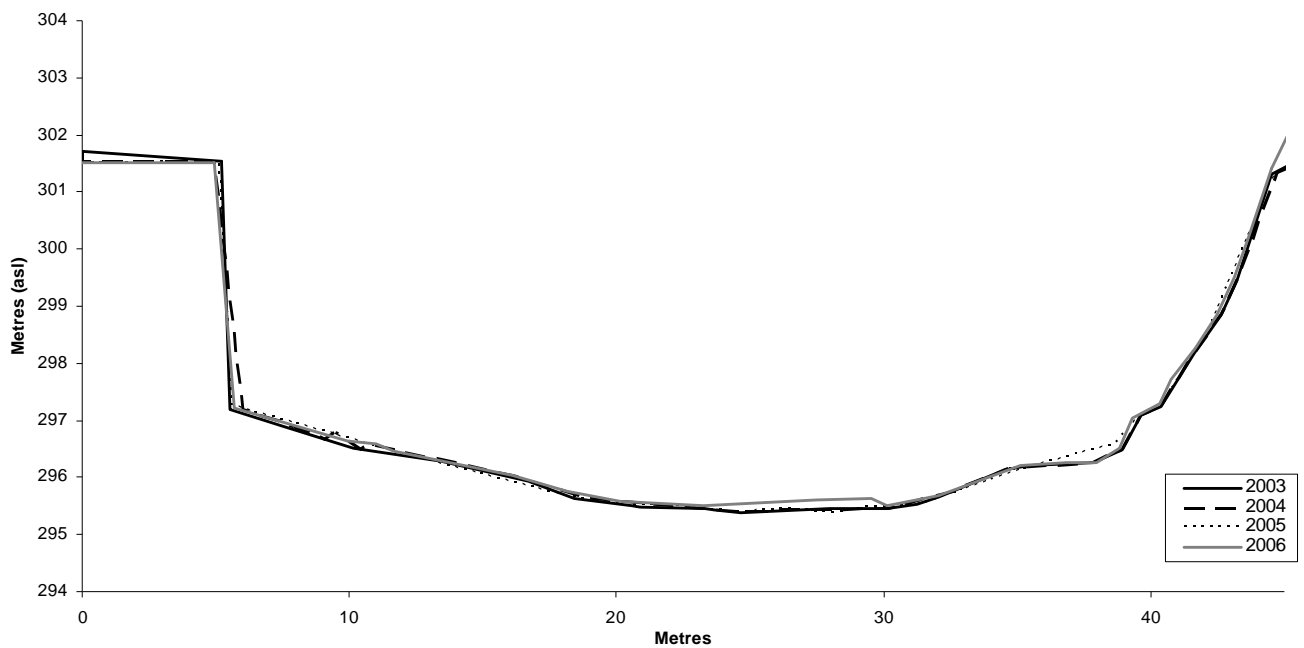
Channel cross sections surveyed at the three reaches of Umbango Creek showed that relatively little change to channel morphology occurred at the log groyne reach during the study period (e.g. Figure 5). This channel stability reflects the generally low flow conditions throughout 2003 and 2004 when the Creek experienced low discharge conditions with flow velocities below those required to entrain cobbles. Minor river freshes, which occurred in August 2003 and September 2004 following widespread rainfall in the catchment had very little impact. Changes to channel morphology as a result of a higher flood pulse in 2005 were evident only at the levee bank reach where substantial bank erosion and thalweg deepening occurred (Figure 6).

Figure 5. Channel cross sections at log groyne reach in Umbango Creek surveyed in 2003, 2004, 2005 and 2006.

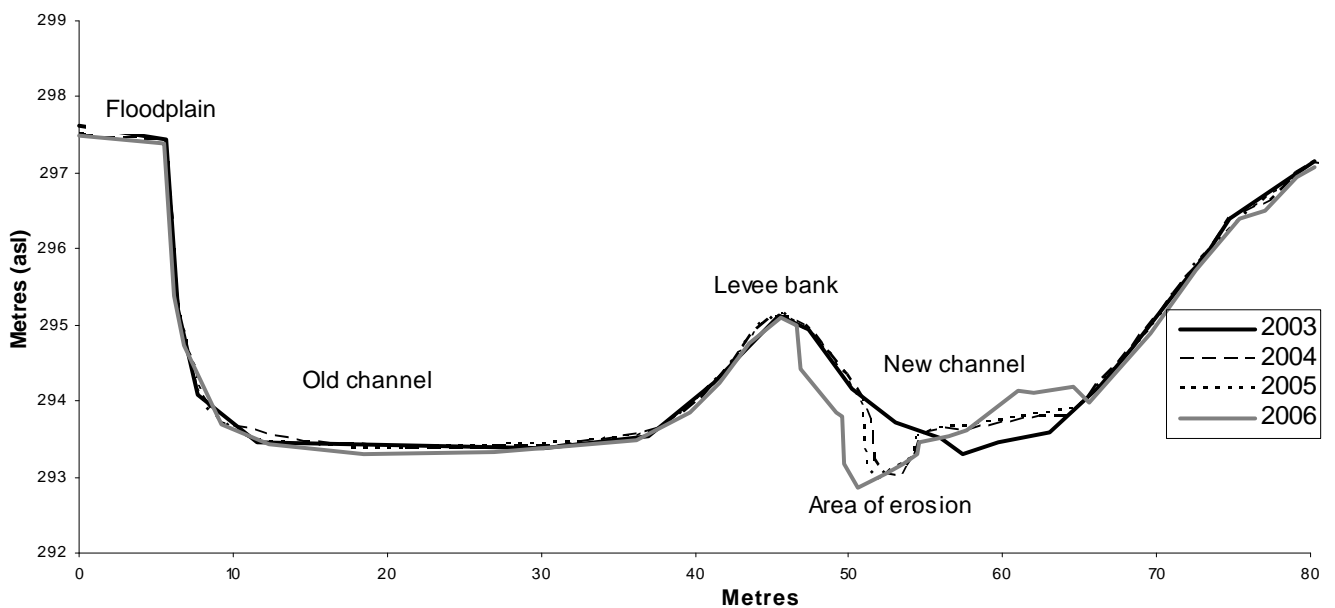
Figure 6. Channel cross sections at levee bank reach in Umbango Creek surveyed in 2003, 2004, 2005 and 2006.

It is apparent from Figure 5 that erosion of the levee bank occurred at the bend axis after the high flows in late 2005. Bend shortening at this reach has increased local channel slope and potential bed shear. The vulnerability of the constructed levee bank to future bend erosion presents a challenge to the on-going success of remediation work in this reach and therefore requires periodic monitoring. However, the lack of a significant breach of the levee bank earthworks during a substantial discharge event suggests an increase in bank strength resulting from enhanced vegetation cover (Hickin, 1984). Additionally, the presence of trees, shrubs, ground cover and in-stream vegetation is likely to have enhanced channel roughness and therefore reduced flow velocity in the study reaches.
